Study on the Mechanism of the Generation of Plaque Defects on the Tooth Surface of High Speed Railway Transmission Gears

Keywords: Transmission gears, Galvanic corrosion, Friction, Wear

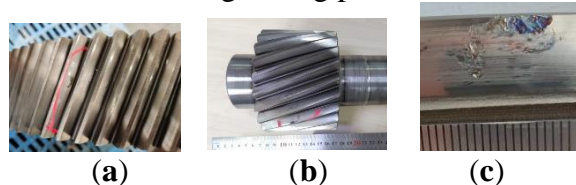
Figure 1: Macroscopic appearance of gear tooth crater defects

The gear set was disassembled and cleaned, and its macroscopic shape is shown in Figure 1. As can be seen from the figure, the defect on the large gear (driven wheel) is located near the root of the tooth, with a patchy melt feature and a tempering colour, and the surface of the tooth around the defect is intact. The defect on the pinion (active wheel) is located near the top of the tooth, basically distributed on the same circumference, the defective surface has obvious tempering characteristics, local blue or light yellow, the internal is a dotted pit loaded molten state, local appearing spot type wear area, the area and the large gear tooth surface spot position corresponds exactly, the defect around the tooth surface grinding traces are clearly visible, no obvious abnormalities, non-defective area tooth surface is intact no bias load bias grinding phenomenon was found [12-13].

(a) Defective large gear (driven wheel); (b) Pinion (main wheel) defects; (c) Crater defects enlarged.

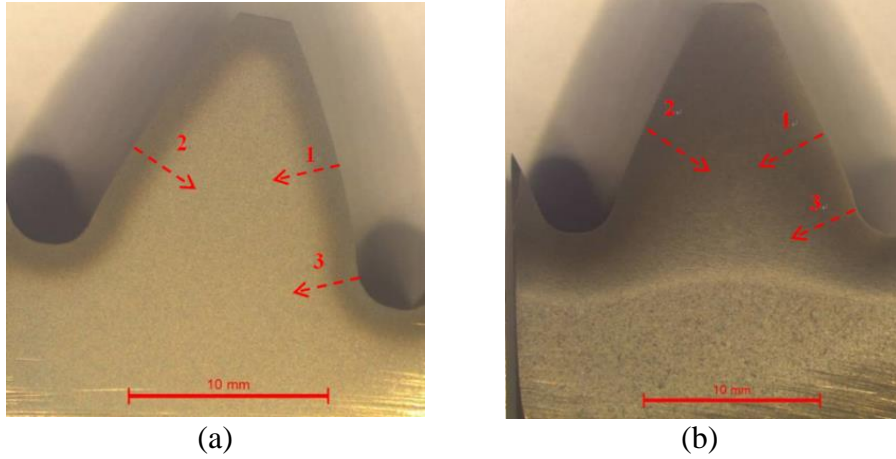
Figure 2: Low magnification photograph of the defective section of the gear

and the sections were made into low magnification specimens [14-18]. Figure 2 shows a low-frequency photo of the erosion by ethanol nitrate solution. The low-frequency erosion shows that the hardened layer of the pinion is uniformly distributed and has the characteristics of carburising quenching; the hardened layer of the large gear is thicker at the top of the tooth and shallower at the root of the tooth and has the characteristics of induction quenching. No abnormalities such as burns were observed on the tooth surfaces of both the large and small gears.

(a) Pinion (main wheel); (b) Large gear (driven wheel).

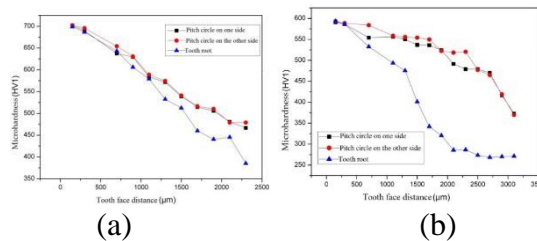
Figure 3: Microhardness gradient curves for large and small gears

The hardness gradient test was carried out at 1, 2 and 3 in Figure 2, and the hardness test curve is shown in Figure 3, which shows that the depth of the carburizing layer of the pinion is: CHD513HV1.0:1.810mm on one side of the pitch circle; CHD513HV1.0:1.798mm on the other side of the pitch circle; and CHD513HV1.0:1.504mm at the root of the tooth. DS435HV1.0:2.845mm on one side; DS435HV1.0:2.830mm on the other side of the pitch circle; DS435HV1.0:1.410mm on the root of the tooth.

(a) Pinion (main wheel); (b) Large gear (driven wheel).

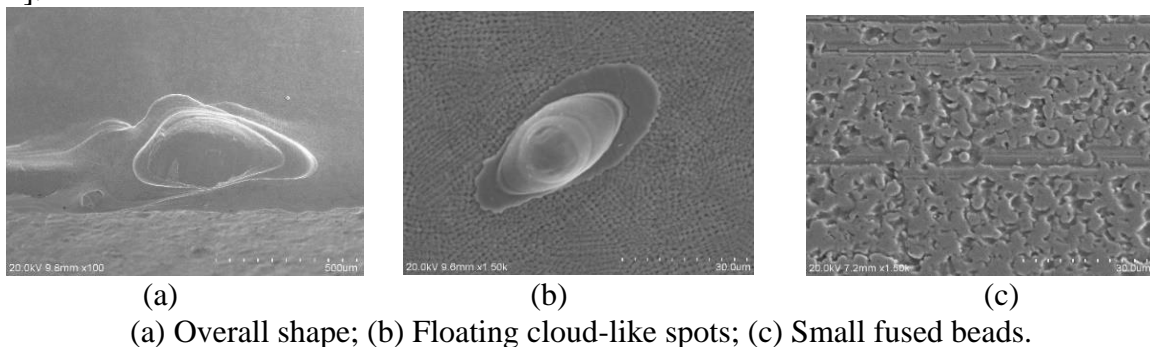
Figure 4: Microscopic appearance of pinion defects

The pinion tooth surface defects at the line cutting system sample, after ethanol ultrasonic cleaning, using Hitachi S-3700N scanning electron microscope to observe the tooth surface crater defects, microscopic morphology as shown in Figure 4. From the overall morphology of the defect, it can be seen that there are puffy cloud-like round spots in the defective depressions, with local presence of fine round beads and a rounded surface with free solidification surface characteristics. Tooth surface defects and normal tooth surface at the junction of the micro-existence of small beads and parallel distribution of tooth surface grinding traces, with galvanic corrosion "molten beads" morphological characteristics.

Galvanic corrosion is due to the action of electric arcs or sparks radiating between the gear meshing tooth surfaces, the formation of many small arc pits with smooth edges on the gear tooth surface, with molten discharge characteristics, the tooth surface will sometimes also appear a large area of burns, the edge of which shows a tempered colour [19-20]. The presence of molten beads indicates that the area was subjected to very high temperatures in service, resulting in localised melting. The high temperatures may be related to the transient high pressures of the HRL lines, where the instantaneous high pressures lead to local spark discharges when the gears are engaged or separated, causing the local temperature to rise sharply and exceed the melting point of the metal, resulting in the formation of molten beads on the tooth surface, also known as galvanic erosion [21-22].

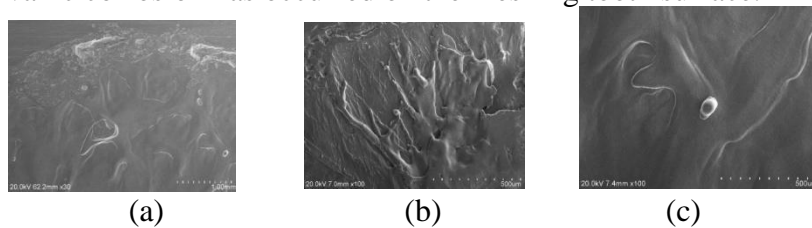
Figure 5: Microscopic appearance of large gear defects

The same method was used for the scanning electron microscope morphology test of the large gear defect, as shown in Figure 5, the defect depression there are floating clouds of round spots, with free solidification surface characteristics, and melt droplets local sputtering. Most of the defect area is polished, the defect at the root of the tooth has obvious plastic extension deformation, a small part has been extended to the root of the tooth unground area, the area against the tooth surface can be seen a large number of craters, the bottom of the crater is relatively smooth, showing a cloud-shaped pattern, has the characteristics of fatigue wear (or contact fatigue). This is due to the fatigue damage that occurs locally when the oil film cannot be established at the defective area during the subsequent operation after galvanic corrosion has occurred on the meshing tooth surface.

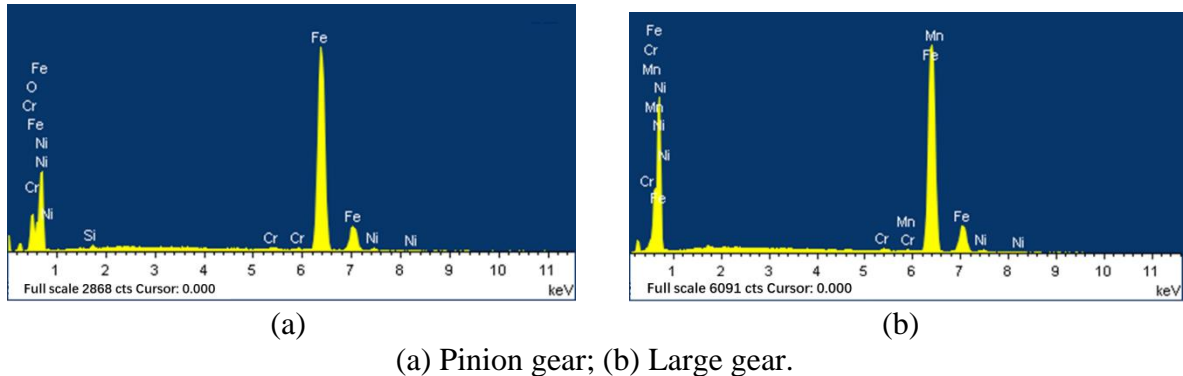
Figure 6: Results of energy spectrum analysis area at tooth surface defects

The results of the energy spectroscopy tests carried out on the defective tooth face, shown in Figure 6, show that the area is dominated by the base elements of the gear steel and no slag defects are characteristic.

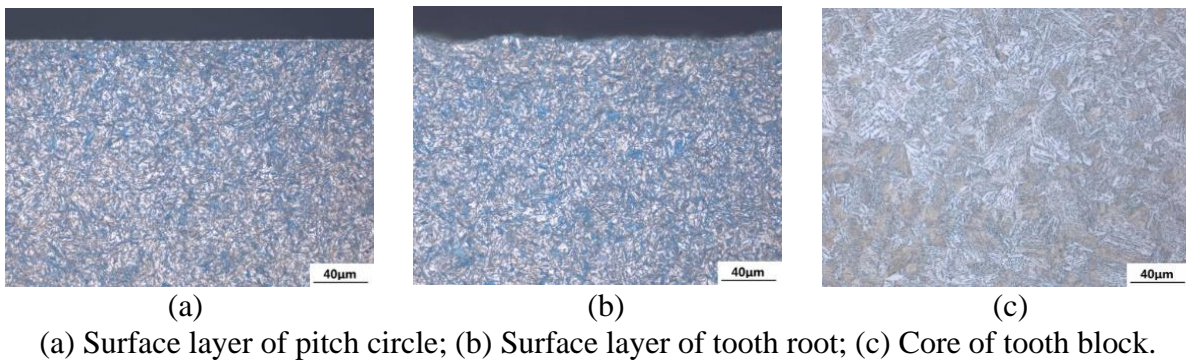
Figure 7: Metallographic organization of the active gear

From the large and small gears on the spot area and away from the spot on the normal substrate were cut metallographic specimens, after inlay, grinding and polishing in 4% v/v nitric acid alcohol solution corrosion, in LEICADMI5000M type optical microscope to observe the microstructure [23-24]. Active gear metallographic organization as shown in Figure 7, by the figure can be seen: active pinion normal regional cross-sectional metallographic organization, pitch round surface layer metallographic organization for needle martensite + about 5% residual austenite + diffuse granular carbide. The surface layer of the tooth root is needle martensite + approximately 5% residual austenite + diffuse granular carbide. The core of the tooth block is bainite + slate-like martensite + ferrite, which is typical of carburising and quenching [25], with no abnormalities in the heat treatment process.

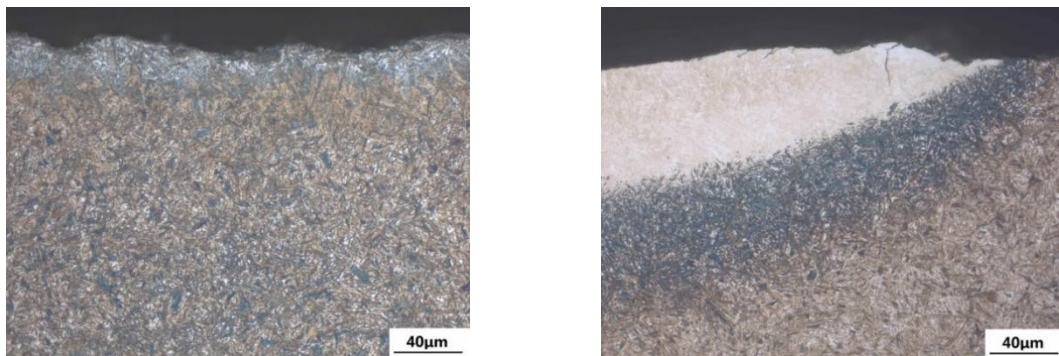
Figure 8: Metallographic organization of driven gear

The surface layer of the pitch circle of the driven large gear and the core of the tooth block are similar to those of the active gear, and no abnormalities are seen in the heat treatment process. The surface layer of the tooth root has a non-martensite layer about 21µm deep, and the sub-surface layer is needle martensite + about 3% residual austenite + diffuse granular carbide, as shown in Figure 8(a). The metallographic organisation of the section at the defect is shown in Figure 8(b), where there is a white bright layer on the surface, a black tempered layer on the sub-surface and a yellow-brown carburised quenched layer on the interior, indicating that the area had experienced higher temperatures and localised micro-cracking sprouting, with shallow crack depths limited to the quenched martensite range.

(a) Surface layer of tooth root; (b) Defective interface.

Based on the above conclusions, the following aspects can be addressed: improve the grinding accuracy of the gear tooth surface to avoid the appearance of obvious grinding tool marks; ensure adequate lubrication between the meshing surfaces of the master and driven gears and carry out regular checks on the oil quality in the gearbox to prevent deterioration of the oil quality; strengthen the insulation control to the ground after the rail is laid to ensure that the leakage current is within the technical requirements and adopt a reasonable grounding device.
