The Analysis on the Causes of the Water Wall Pipe Burst in Industrial Boilers

Abstract: In view of the water wall pipe burst of the heating industrial boiler, the research group carried out the water vapor sample analysis, the incrustation scale analysis of the typical rupture test pieces and the metallographic analysis during the operation. The researchers studied the cause of boiler pipe explosion from the chemical and metallographic aspects of materials, and found that most of the damage forms were brittle explosion, and the metal surface protective film was completely or mostly dissolved and damaged, resulting in a wide range of water wall pipe damage. The macroscopic inspection of the appearance of the water wall pipes in the furnace and the measurement of the thickness of the water wall pipes should be carried out during the shutdown and maintenance period, and the pipe sections that have not met the safety requirements should be cut off. During boiler shutdown and maintenance, other water wall pipes at the same position were checked with a water-cooled wall pipe tester. This provides effective treatment measures to solve the water wall pipe burst of the boiler.

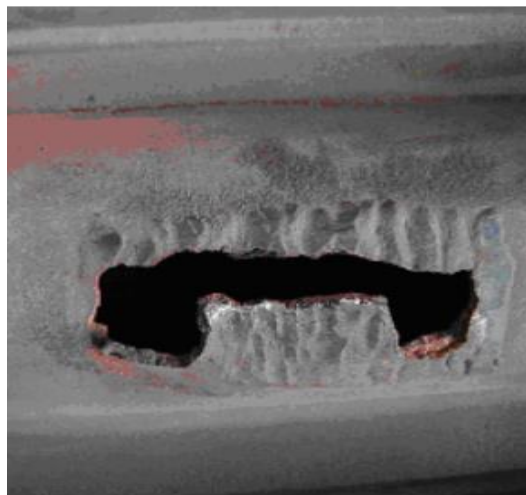
Figure 1: Appearance of window shaped bursting port.

The research group selected two bursting ports in the representative failure pipe samples for research. Bursting port I: It is located near the weld crater of the water-cooled wall pipe, in a window shape, and cracks longitudinally along the pipe. The maximum longitudinal opening is 102.36mm, and the maximum transverse opening is 22.52mm. There is no obvious plastic deformation in the pipe section near the bursting port, and the edge is rough, showing brittle fracture morphology. The pipe wall is obviously thinner. The appearance of the bursting port is shown in Figure 1, and the inner surface state is shown in Figure 2.

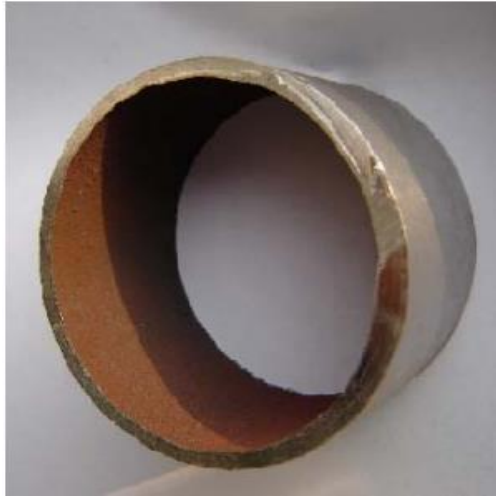
Figure 2: Inner surface of pipe section near window shaped bursting port.

It can be seen that there is a thin layer of uniform reddish brown sediment on the inner surface of the pipe near the window shaped bursting port I, and the structure is relatively loose. Moreover, the deposits on the pipe wall at the fire facing side are obviously more than those at the back fire side, and dish shaped pits of different sizes can be seen after washing away the deposits.

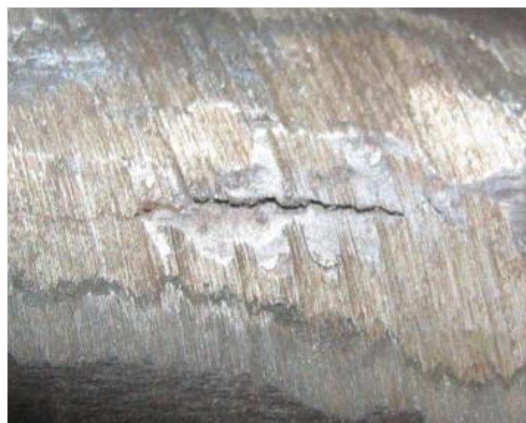
Bursting port II: It is located near the elbow and presents crack-like burst along the longitudinal or transverse direction. There is no obvious plastic deformation in the pipe section near the bursting port. Oval corrosion products protruding from the inner surface can be seen on the inner wall of the bursting port, which is loose in texture. After removing the corrosion products, there are dish shaped corrosion pits on the inner surface of the pipe wall, with obvious corrosion thinning and corrosion under the scale. The appearance of the bursting port is shown in Figure 3, and the inner surface near the pipe section is shown in Figure 4. The morphology of pipe metal substrate after removal of corrosion products on inner surface is shown in Figure 5.

Figure 3: Appearance of crack-like bursting port.

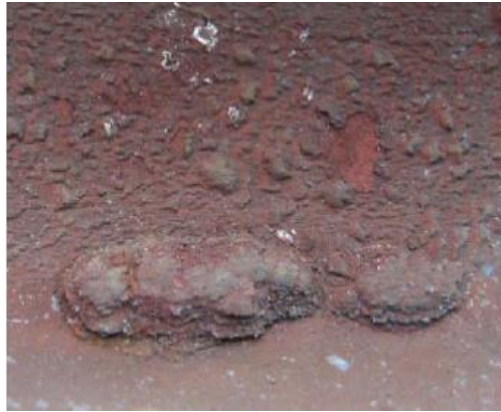
Figure 4: Inner surface near the crack-like bursting port.

Dense bulges with a diameter of 1mm to 5mm can be seen on the inner surface of the pipe section near the crack like explosion II. The color of the bulge surface is reddish brown, and the secondary layer is black powder. After peeling off part of the corrosion products, white salt concentrate can be seen. After pickling the corrosion products, there are dish shaped pits with different depths below the bulge. On the inner wall near the bursting port, there are discontinuous oval corrosion products protruding from the inner surface, with a length of 3-23.65mm and a thickness of 1-7mm. The texture is relatively loose, and the crack is located in the middle of the corrosion pit. After removing large corrosion products by mechanical method, silvery white metal matrix with small cracks, reddish brown corrosion products, black Fe_3O_4 and white salt deposit can be seen at the bottom of the corrosion pit. The depth of the corrosion pit can reach 3.1mm.

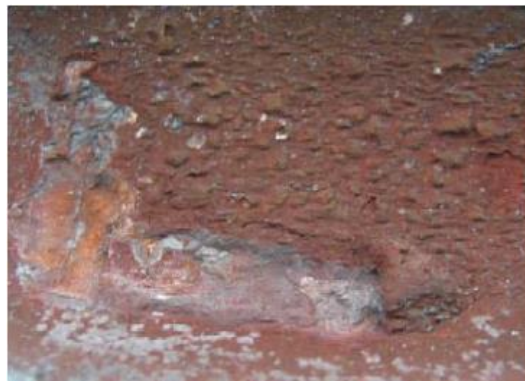
Figure 5: Morphology of pipe metal substrate after removal of corrosion products on inner surface.

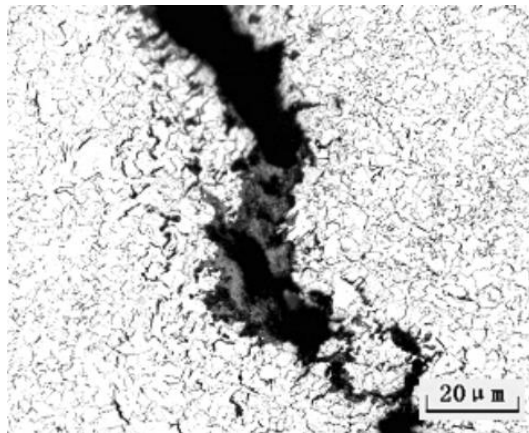
Metallographic analysis has been carried out on bursting port I and II. It can be seen from the metallographic diagram near the bursting port I in Figure 6 that the metallographic structure of the material at the bursting port I consists of ferrite and a small amount of pearlite. A large number of intergranular cracks can be observed, and the pearlite near the crack is severely decarburized.

Figure 6: Metallographic diagram of bursting port I.

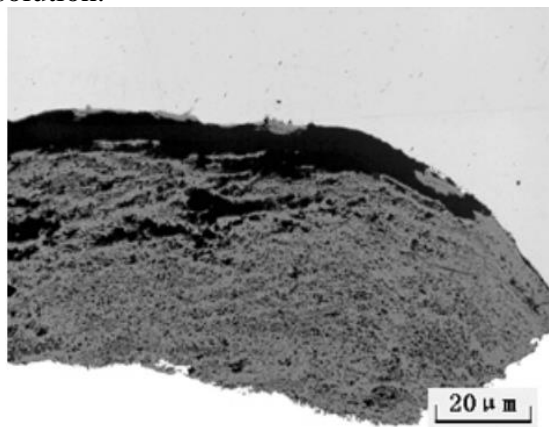
It can be seen from Figure 7 that there are a large number of black stripe microcracks in the metal matrix of the inner wall of the water wall near the bursting port II. The cracks are distributed along the grain boundary or exist at the interface between pearlite and ferrite. There are no corrosion products inside the crack. The scale layer is mostly separated from the matrix, and only a small amount is connected with the matrix. In Figure 8, the hydrogen embrittlement cracks in the matrix at a magnification of 600 times can be clearly seen in the metallographic diagram of the pipe etched with 4% nitric acid alcohol solution.

Figure 7: Metallographic diagram near the bursting port II (gray in the lower part: the scale layer, black in the middle: the gap, the uppermost part: the metal substrate).

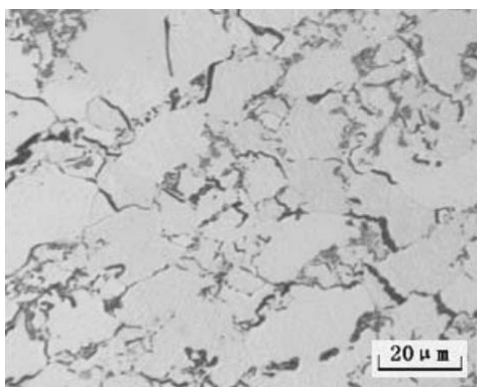
Figure 8 Metallographic diagram of bursting port II at 600 times magnification (etched by 4% nitric acid alcohol solution).
