A Study on the External Wall Insulation System Safety Accidents in a Residential Community in Nanjing, China

3. Analysis of External Wall Insulation System Safety Accidents

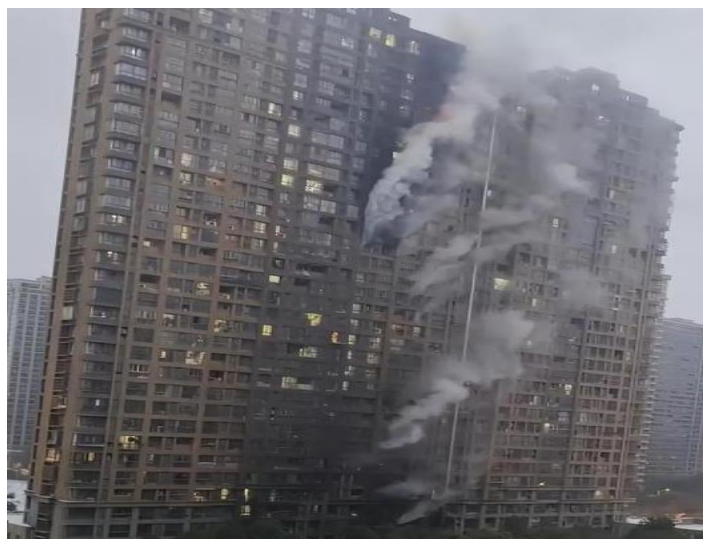
Figure 1 Fire spread in the Polyurethane Thin-Plaster External Wall System

At 4:35 a.m. on February 23, 2024, a major fire broke out in Building 6 of Mingshang Xiyuan Residential Complex, located at No. 9 Xishi Road, Yuhuatai District, Nanjing. Due to the chimney effect, the polyurethane thin-plaster insulation system caught fire, causing the flames to spread rapidly. The resulting fire and high-temperature toxic smoke quickly penetrated the apartments through external windows located within the lightwell, leading to casualties. Figure 1 shows the fire spread on the external wall of Building 6 in Mingshang Xiyuan, Nanjing.

Although polyurethane foam in thin-plaster systems has excellent thermal insulation and strong adhesive properties, its thermal stability and flame-retardant performance are relatively poor. It is especially flammable when exposed to high temperatures or open flames. In this case, the polyurethane material had not been effectively treated with fire-retardant additives and was classified as a B2-grade combustible material. This did not meet the regulatory requirement that external wall insulation systems for high-rise buildings must use A-grade non-combustible materials, making it a direct factor in the rapid spread of the fire.

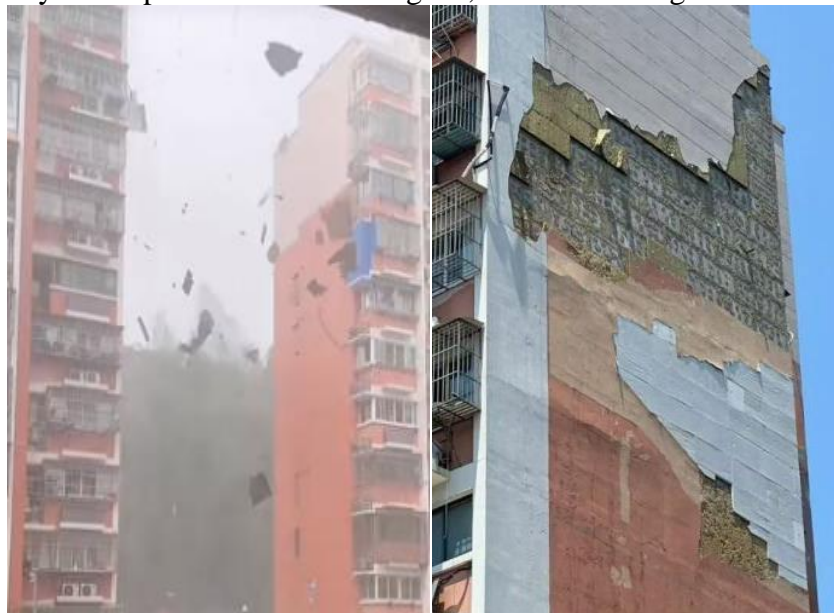
On the evening of August 5, 2024, a sudden heavy rain hit parts of Nanjing. Baiyun Yaju Residential Community, located in Gulou District, was within the affected area. Strong winds caused large sections of the external wall insulation layers on several buildings to peel off. The falling debris damaged cars parked below, and multiple buildings in the community showed signs of exterior wall delamination. The exterior wall of Building 14 in Baiyun Yae Yuan Residential Area in Nanjing City has experienced wall falling off, as shown in Figure 2.

Figure 2 External Wall Detachment of the Rock Wool Thin-Plaster System

On-site observations indicated that the area of detachment extended approximately six stories in height and over four meters in width. The exposed wall surface revealed deteriorated and mottled remnants of rock wool insulation, creating a stark contrast with the intact portions of the wall.

Preliminary analysis suggests that the primary cause was the aging and cracking of the wall's

plaster layer, which allowed rainwater to penetrate and saturate the adhesive layer, leading to debonding and detachment of the insulation. Additional contributing factors include the building's location at a wind corridor, where the "Venturi effect" exerted long-term shearing forces on the insulation, and unauthorized exterior wall renovations by residents that compromised the insulation layer, allowing water ingress and further weakening adhesion.
