# Failure Analysis of Hub Bolt of Main Landing Gearing

**Keywords:** Hub bolt; Cadmium plating; Hydrogen embrittlement.

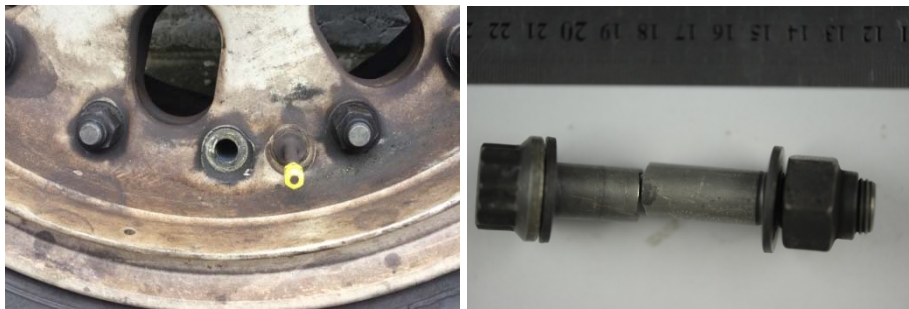
Bolt mounting position is shown in Figure 1a. There are not structure parts or other parts that occur collision or friction with the bolt. The macro morphology of the fracture bolt is shown in Figure 1b. The fracture position is located at the middle end of the screw bolt. Hub bolts stress state is tensile stress, usually the root of the bolt is stress concentration area, while the load distribution in middle of the bolt rod is relatively uniform.

Figure 1: Macro appearance of installation site and broken bolt

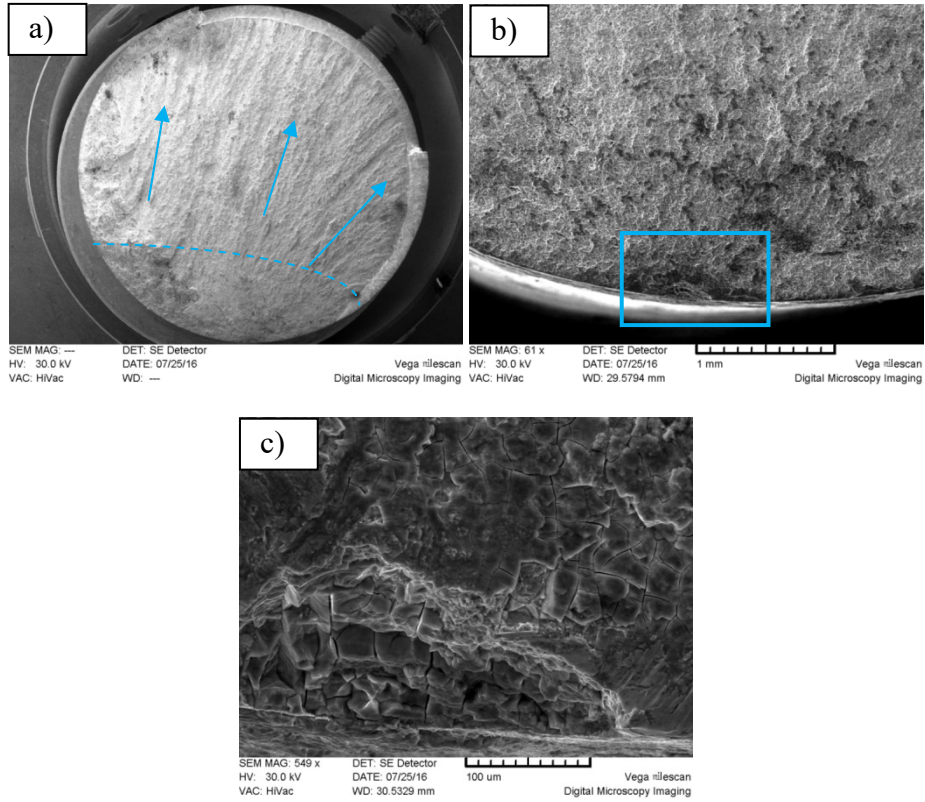
The microstructure of the fracture surface of the bolt is shown in Fig. 2. The fracture surface is characterized by fatigue fracture. The boundaries of the extension are shown by the dashed blue line in Figure 2a. The direction of crack propagation is shown by the arrows in the figure. The micro-morphology of the crack source region is shown in Fig. 2c, which is characterized by point source. The origin of the crack is located in the concave of the surface, and there are obvious cracks in the vicinity.

Figure 2: Microstructure of bolt fracture

The above characteristics show that the fracture of the bolt is fatigue fracture, the crack originates from the pits on the surface, the expansion area is brittle intergranular cracking, and the area occupied by the crack growth area is small, which is low-cycle fatigue characteristic.

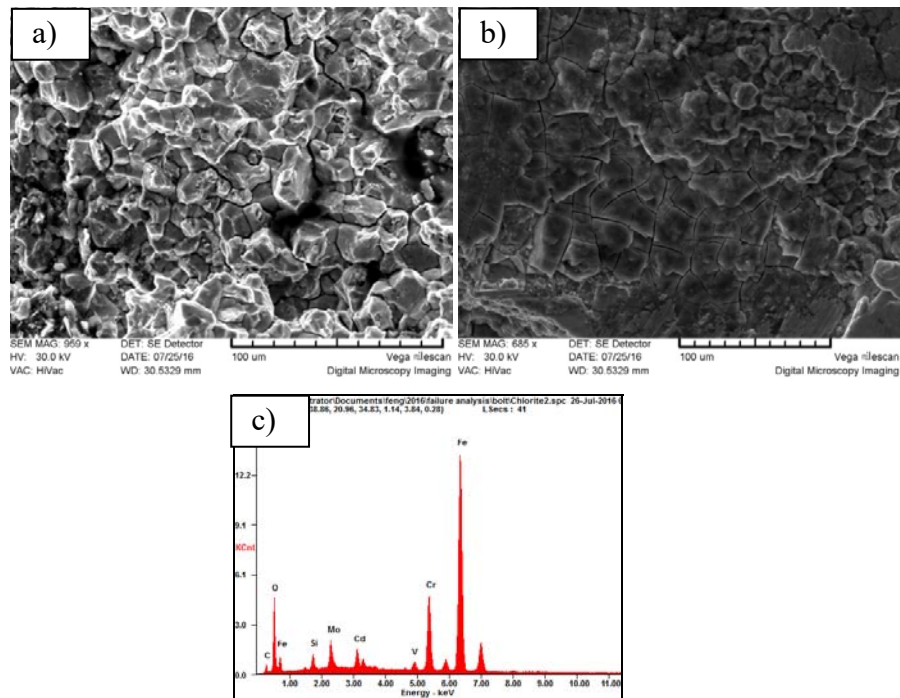
The microcosmic morphology of the crack propagation region is shown in Fig. 3, and the microscopic morphology is intergranular cracking, and the surface of the crack is characterized by "claw pattern". A large number of secondary cracks were observed in the vicinity of the crack source, and the cracks were as shown in Fig. 3b. The Energy Distribution Spectrum of the crack propagation region shows that the metal cadmium content is abnormal. Cadmium is usually used as a protective coating and the matrix does not contain such a large amount of Cd.

Figure 3 Intergranular sugar block morphology and secondary crack morphology near fatigue source a) Intergranular cracking in crack growth region; b) Crack near the crack source; c) Energy spectrum curve of crack growth zone

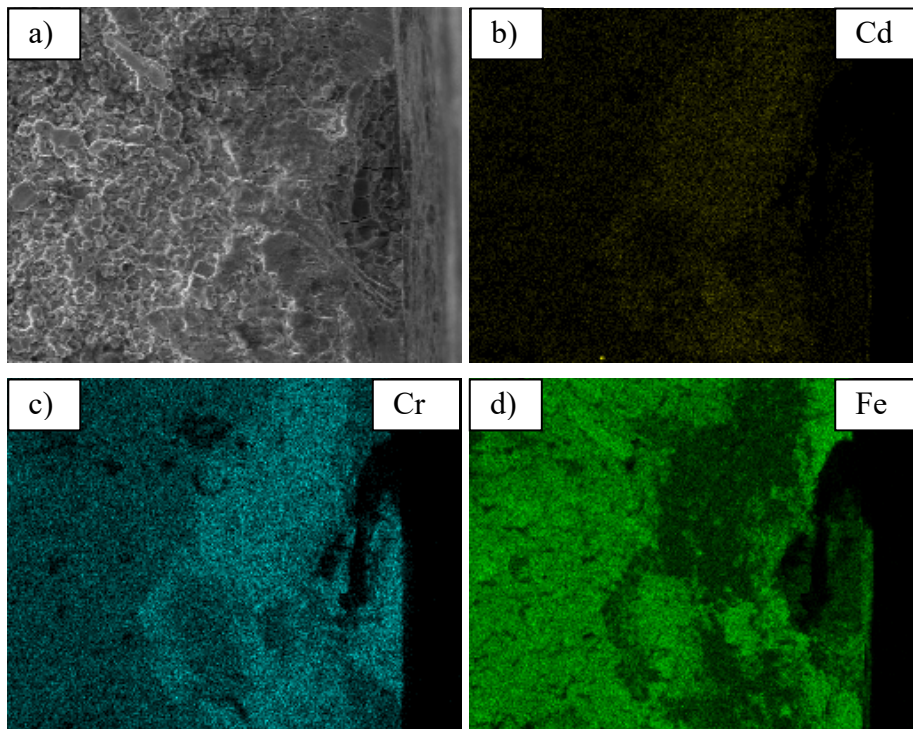
The surface scanning mode of EDX spectrum is used to analysis the law of various elements near the location of fracture, as shown in Figure 4. The Cd content in the crack source region is high (Fig. 4b), and gradually decreases along the crack propagation direction. The Cr content of source region is high, and also decreases gradually along the direction of crack propagation, and crack area the content of Cr was higher. The Fe content of crack source region is low, but increases gradually along the direction of crack propagation. The results of energy spectrum scanning show that the fatigue crack originates from the micro-cracks under the Cd coating, and the Cr in the micro-crack region is abnormally high.

Figure 4: Distribution of chemical elements near fatigue source (upper left is the number of pictures, right is the corresponding chemical elements)

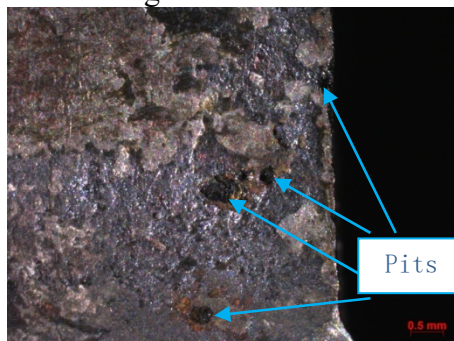
The macroscopic topography of the bolt sidewall is shown in Fig.5. In the vicinity of the cross-section location found a number of pits, the middle position of pit is dark gray, and the surrounding matrix is gray, the colour between the two areas is obvious difference. Finally, one of the pits is located at the location of the bolt fracture section, which is the origin of the fatigue crack. The deposits around the pits were cracked, and micro-cracks were observed in the pits. Cooperation with area-scan function of Energy Distribution Spectrum (EDS), as shown in Fig. 6, the normal region is chrome-plated, and the Cd deposit at the crack region of the dimple area falls off, and the Cr content in the crack is obviously higher than that in the other places. The distribution of Fe in the matrix is obviously lower than that in the surrounding area.

Figure 5: Corrosion pits on the flank of fracture

The higher Cr content in the pits, as seen from the pits on the sidewall surface, indicates that the pits already existed prior to the chromate passivation treatment. A large number of Cr salt accumulation in the pit. So that, the pits may be formed in the cadmium plating process or its subsequent hydrogen removal process. In the subsequent chromate passivation treatment, chromate deposits cover the surface of the pit, resulting in the defect is not obvious, which passed the NDT test.

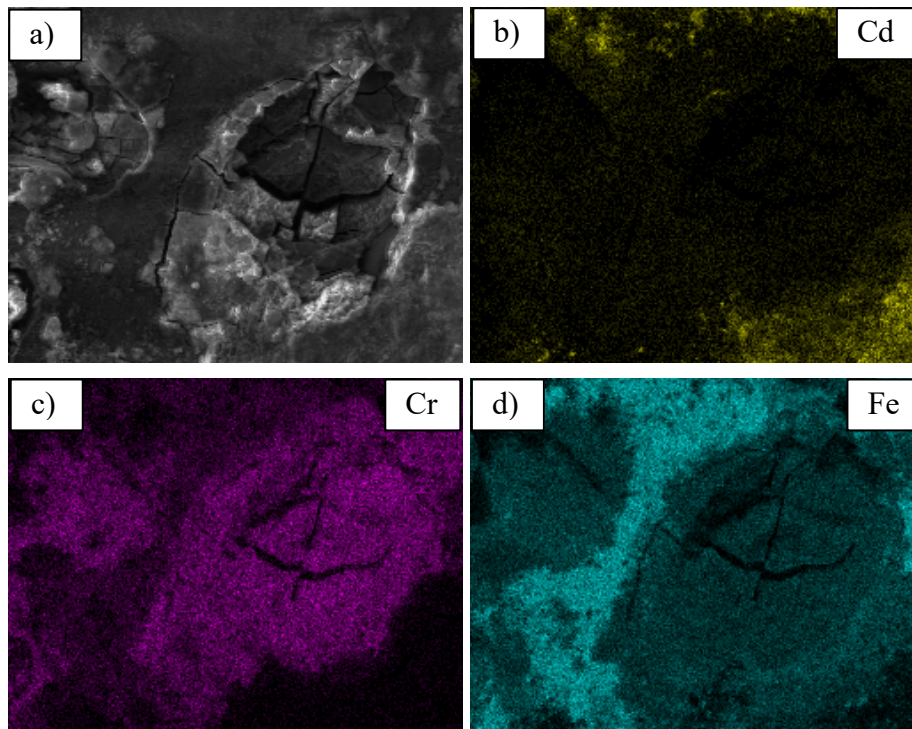
Figure 6: Distribution of chemical elements of corrosion pits (upper left is number of pictures; upper right is corresponding chemical elements)
