Fault analysis and treatment of 220kV Gas Insulated Substation pillar insulator adjusting bolt

2. An accident case of 220kV GIS pillar insulator adjusting bolt

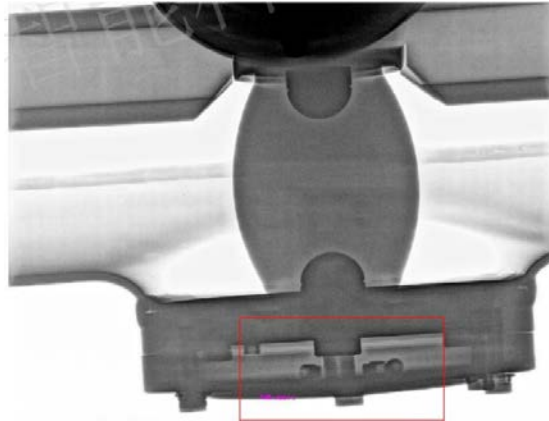
A substation 220kV GIS, junction group YN,d11, products delivered in July 2015. It was put into operation in 2015, and chromatographic tracking test was conducted according to the provisions of "maintenance procedures for power transmission and transformation state" after operation. August 26-29, 2019: at the request of the equipment department of the provincial company, contacted sichuan saikang intelligent technology co., ltd. to conduct X-ray detection and vibration test on 220kV composite electrical appliances of a substation. It was found that the main primary interval of bus in 220kV section was between the 220kV busbar and the 220kV busbar, and a pillar insulator adjustment screw was loose near the 220kV busbar. Danbao 2 line 22201 knife brake B phase contact protruding shield about 5.97mm. As shown in figure 1:

Figure 1 Adjust screw loose

4) The hexagon socket bolts dropped off in the field for adjustment bolts do not play the role of fixing the support insulator, which is fixed by one M20*45 and four M12*25 bolts in the center. The adjustment bolts may have poor fastening in the assembly process in the factory, which may lead to looseness due to electrodynamic vibration during a period of operation.

1) Operation and maintenance personnel shall restore loose adjustment screws and tighten the remaining screws.

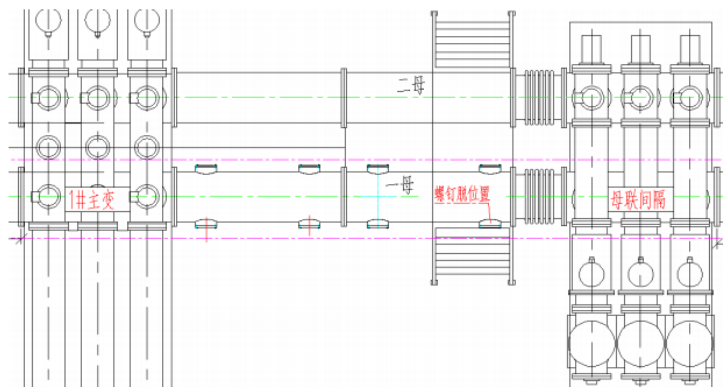
Figure 2 Screw drop position

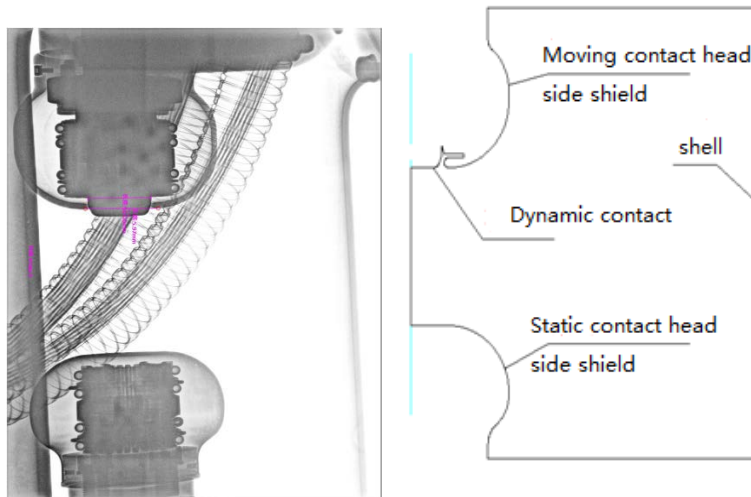
Figure 3 X - ray photo of highlight shield of danbao 2 - line I female switch B

Danbao 2-wire moving contact highlights the problem of shield cover. Since the onsite opening and closing of the switch has been aligned, there is no problem with the external indicator inspection. It is only possible that there is an oversight in the assembly process of the manufacturer, leading to the failure of all moving contacts to be retracted into the shield cover.

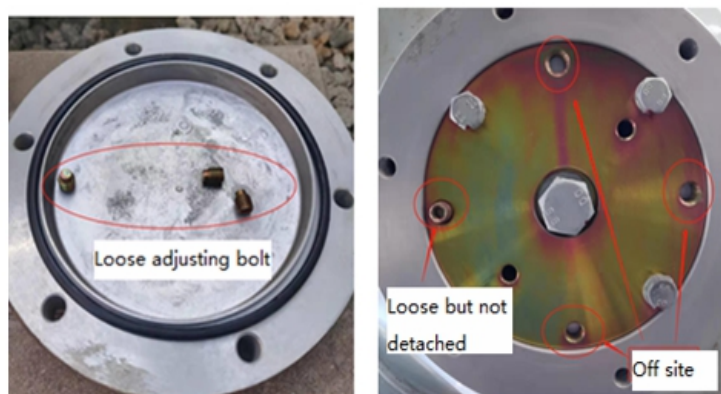
Figure 4 Adjust screw loose part to open cover

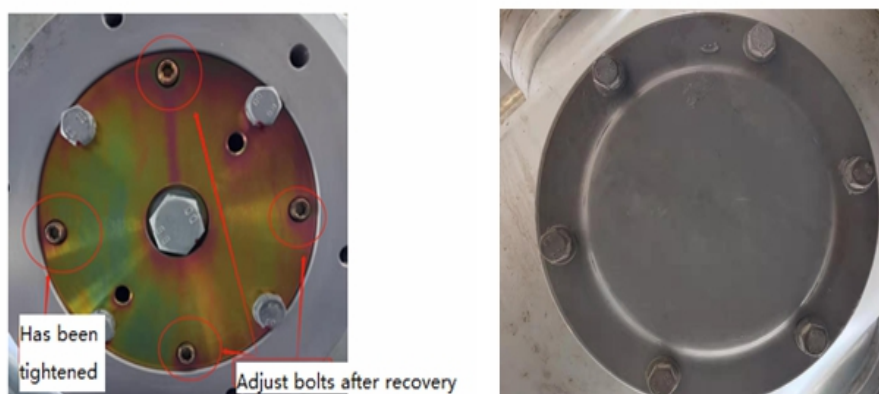
Figure 5 After the screw looseness is restored

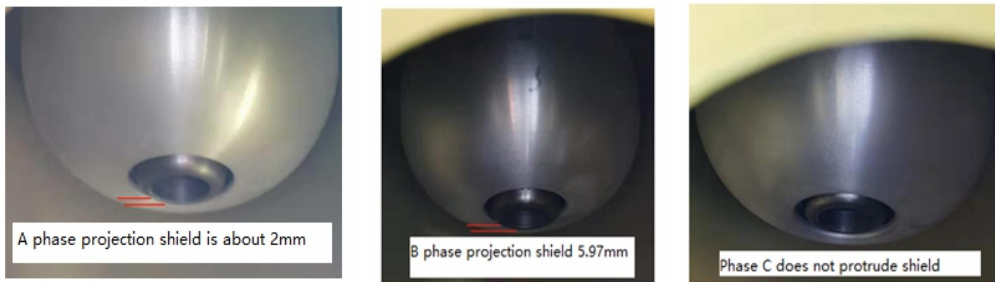
Figure 6 Danbao 2 - line I female switch before three - phase dynamic contact processing

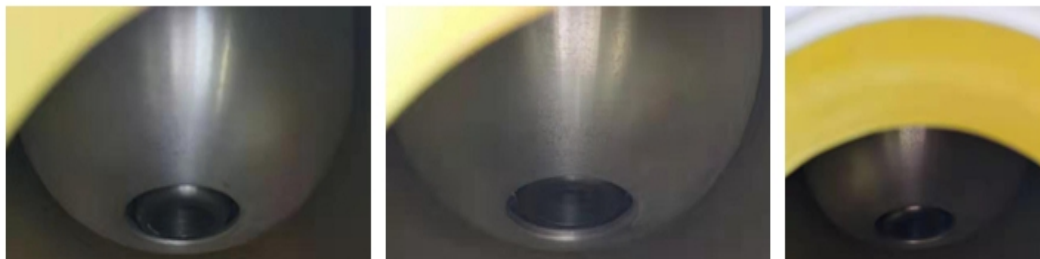
Figure 7 Danbao 2 - line I female knife brake after three - phase dynamic contact processing

2) The 3-phase dynamic contact of danbao 2-wire return to normal, that is, the tripping of the

brake is in place (no shielding cover is protruding), and the insertion depth of closing meets the requirements (greater than 38mm).

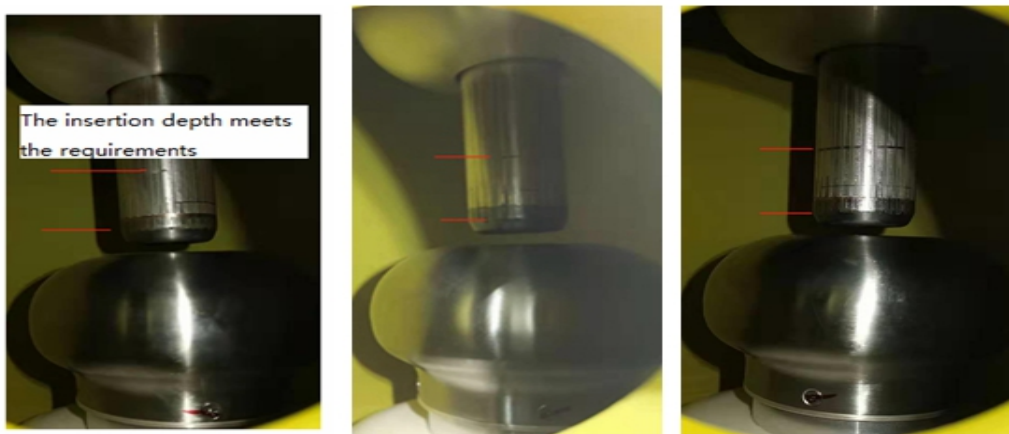
Figure 8 The insertion depth of danbao 2-wire I female knife gate can meet the requirements after three phase dynamic contact processing

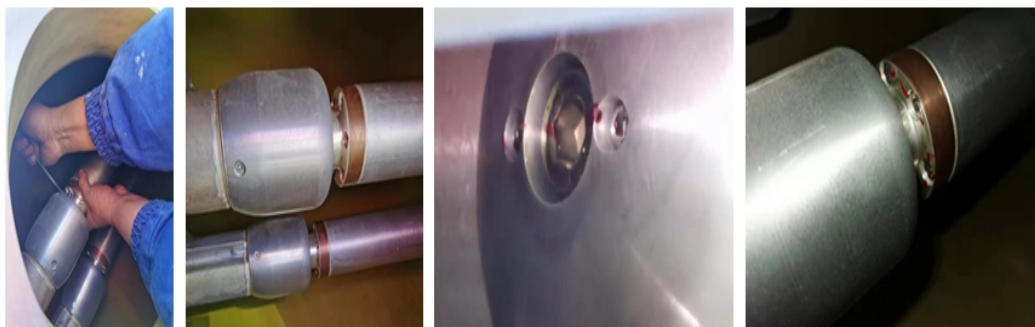
3) The equipment manufacturer shall tighten the suspected loose part of the internal fastener. The bolts that can be observed in the field are marked, and the looseness is not found in the field.

Figure 9 Maintenance maintenance personnel on the site busbar fastening bolt inspection
The field test of sectional circuit resistance is qualified.

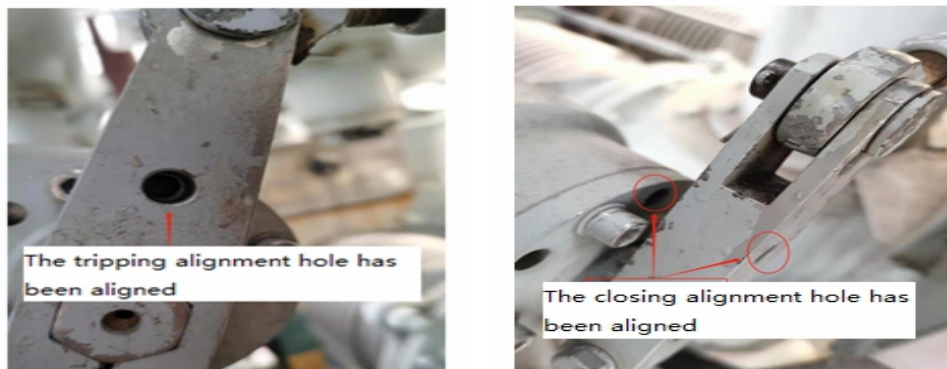
Figure 10 The opening and closing alignment holes have been aligned
