Test Method and Precautions for Grounding Current of Transformer Core

Keywords: transformer, core, grounding current, test method

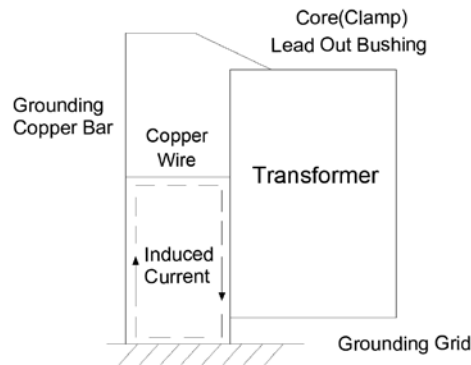
Fig.3 Typical non-standard iron core grounding installation method

After analysis, because there were many connection points between the core grounding down lead and the transformer shell, the induced current was generated due to the closed circuit in the alternating magnetic field. This was the reason for the abnormal value of core grounding current. This was similar to the typical non-standard grounding installation mode of the transformer core with the core grounding down lead first connected to the transformer bottom shell and then grounded, as shown in Figure 3.

In view of the problem that the grounding current measurement value was abnormal due to the improper installation of iron core and clamp grounding down lead, two schemes were adopted by the tester. One was to isolate the metal connection point between the grounding flat iron and the transformer shell with insulator, so as to eliminate the loop formed by the grounding flat iron and the transformer body. The other was to cancel the original grounding mode and direct the iron core guide rod to the grounding grid at the bottom of the transformer. For transformers that cannot be rectified, the current value above the metal connection point shall be measured as the accurate measurement value. After rectification, the measured value of core grounding current was normal, as shown in Table 3.
