# ***Explosion Accidents Evaluation of MV. Gili Cat II using Apollo Root Cause Analysis***

**Abstract:** According to the National Transportation Safety Committee (NTSC), the highest percentage of the accident (2007-March 2017) is fire or explosion (38%). MV. Gili Cat II had been exploded on September 15th, 2016 at Padangbai port, Bali. Therefore, the accident investigation is to investigate what are root causes of this explosion. The investigation was utilizing Apollo Root Cause Analysis methodology. The research shows that the explosion was probably caused by - electrical wiring system, static electricity around the vessel's fuel tank and hull. Purposes of this study are to reanalyse the root cause of the explosions on the ship, to evaluate fuel oil and electrical system of outboard engines according to non-conventional vessel standard (NCVS). In addition, there is no earthing system of the vessel. It strongly indicating the presence of static electricity to reasonably take place. On the other hand, there was evidence showing fuel was spilled when refuelling. Other evidence showed that significant amount of fuel gas flow from leaking fuel line to the compartment below deck. The

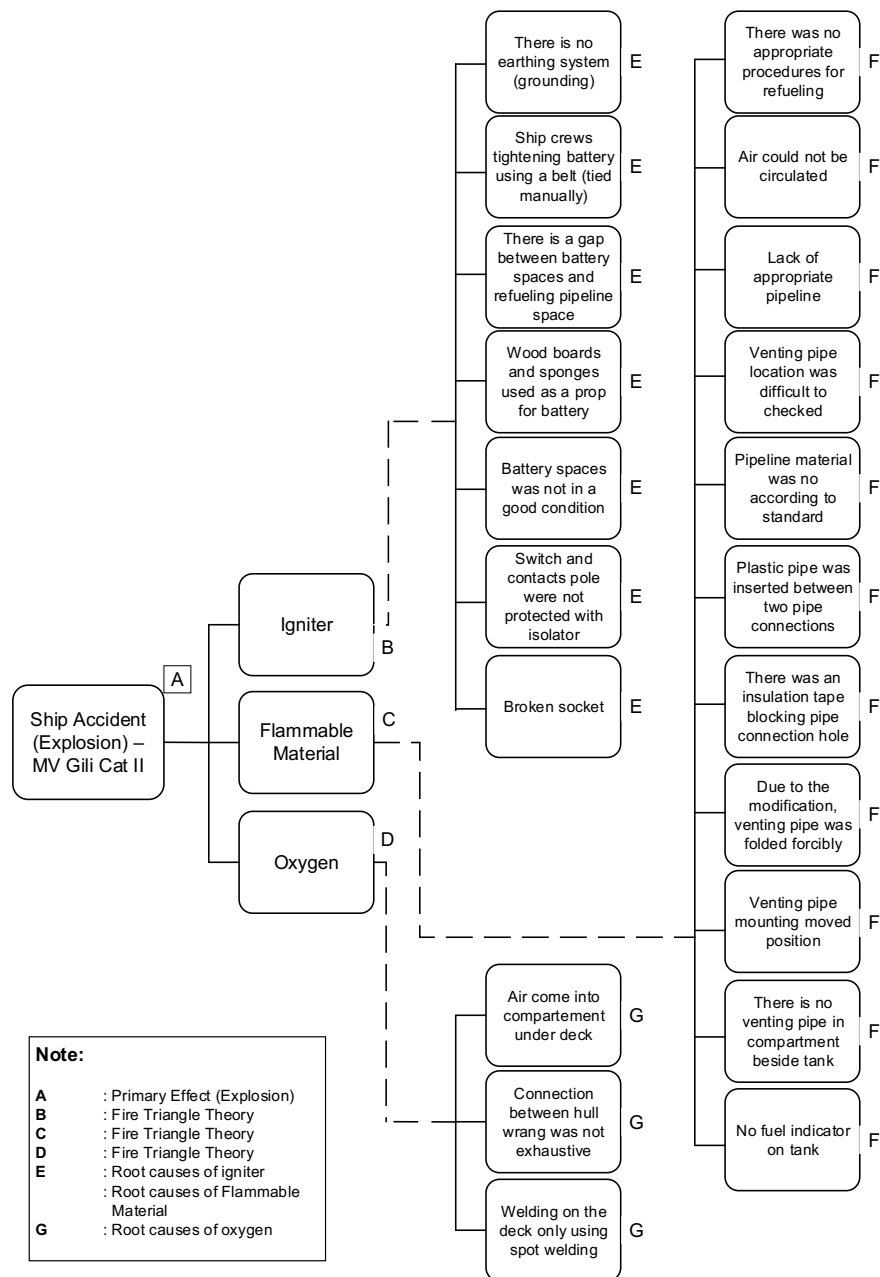
Figure 3: MV. Gili Cat II Explosion Root Cause Analysis

The first stage of ARCA methodology defines the problem. Problem definition is explaining "what is the problem", when (date, time) the problem happens, where (location), significance. The detail root cause analysis of MV. Gili Cat II explosion is described in Figure 3. The author is classified each cause based on fire triangle theory and interview/discussion with the NTSC Investigator.

1. There are some conditions onboard that became the main cause of the explosion. Conditions that became the main cause of Igniter factor are:
  - The bad Electrical wiring system
    - a) Tightening battery using a belt tied manually. In this condition, it evident with battery compartments cannot prevent movement due to the motion of the vessels.

- b) Wood boards and sponges used as a prop for battery.
  - c) Switch and contacts pole are not protected by the isolator.
  - d) Battery Spaces is not in good condition
  - e) There is a gap between battery spaces and refueling pipeline space. This condition could make a battery moving due to the motion of a vessel and the connector to the battery could be broken.
  - f) Brocken Socket
- Static electricity is indicating around the tank and hull.
  - There is no earthing system on the tank and hull. Earthing at the tank is needed to prevent explosion or etc.

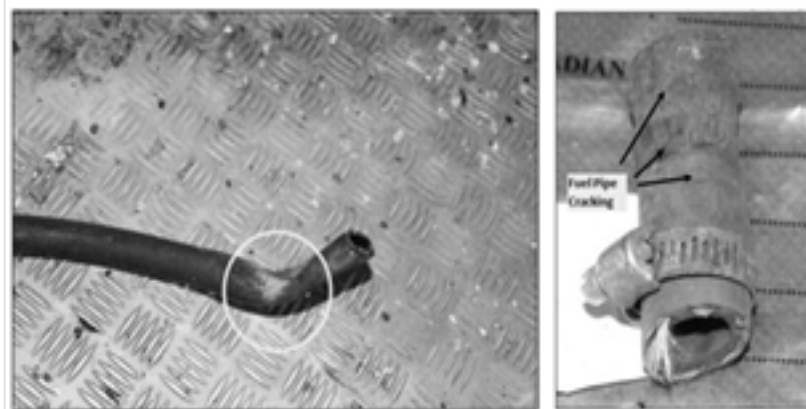
Based on the NTSC Investigation the main factor of flammable material is saturated gas of the fuel oil. Saturated gas estimated coming from fuel oil pipeline of engines and there is a fuel spill when refueling. MV. Gili Cat II was refueling manually and this condition is not in accordance with the standards. Refueling for fuel tanks capacity exceeding 10 liters shall not be used a gravity feed fuel (refueling manually) [6].

Based on NTSC investigation fuel pipelines and venting pipe were using the flexible fiber-type hose. It should be used a standard material such as SAE 30R9-Fuel Injection Hose Medium-Pressure Coupled and Uncoupled Synthetic Rubber Tube and Cover [6]. Saturated gas was accumulated in a compartment beside the tank. This saturated gas cannot release from compartment because ventilation system did not work well. It is because of venting pipe was not in good condition, venting pipe mounting position was moved, and lack of venting pipe in a compartment beside the tank. Venting pipe condition was folded, there was a plastic pipe inserted between two pipe connections, there was an insulation tape blocking the hole in the pipe connection.

The condition of the fuel pipeline was not in a good condition. Based on NTSC Investigation, pipe connector has been corroded and fuel pipe condition has been brittle. Those conditions are described in Figure 4 a) and b). Those conditions are caused by ship crew didn't check well and regularly and materials that do not accordance with standards. Venting pipe folded caused by venting pipe was not using standard material (flexible pipe) and venting pipe folded forcibly. The venting pipe mounting was located above the tank before fuel tank modification, then it moved to the side of the tank. This indicates that venting pipe mounting cannot be used in the original construction. Venting pipe holder that located on the side of the tank would make fuel flow into venting pipe when the tank is full. All conditions made saturated gas cannot release.

Figure 4: a) Venting pipe folded. b) fuel pipe cracking (brittle) [8]

There are some recommendations for venting pipe. The tank shall be vented into the open air. Area of the venting pipe shall not be less than 1.25 times the area of the filling pipe if the tank is filling affected by the pump. The pipe shall terminate in a gooseneck on the open deck. Where the diameter of the pipe outlet exceeds 18 mm, a corrosion-resistant wire gauze screen shall be fitted. A short flexible section of the hose length no more than 760 mm may be incorporated into the vent pipe for vibration damping or to facilitate installation. Pipe shall be made of reinforced synthetic rubber of a type resistant to fuel, salt water, and vibration. The flexible section of hose shall be fastened to the rigid section of the vent with two corrosion-resistant clips at each end. The material should be used a standard material such as SAE 30R9-Fuel Injection Hose Medium-Pressure Coupled and Uncoupled Synthetic Rubber Tube and Cover.

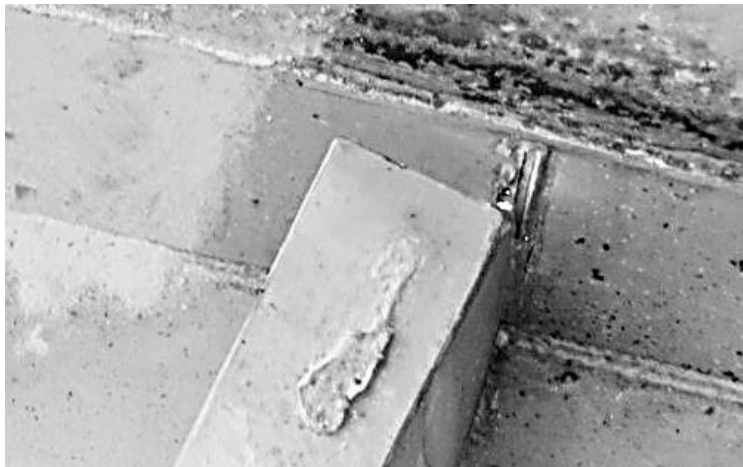
- The compartment below deck is not gastight
- Only using a spot welding

Evidence for there was only a spot welding on the deck is described in Figure 5. Compartment beside tank is not gastight, so there is an oxygen in it. There was some hollow point on the main deck, so this is an access for oxygen to entry to the compartment below the deck (explosion location). Based on NTSC investigation, connection hull and wrang was not exhaustive. This condition also becomes an access for oxygen to entry to the compartment.

Figure 5: Spot welding on the deck [8]
