The Protection of Traditional Residential Buildings in Huize Ancient City Taking No.37 Courtyard of Sandao Lane as an Example

Abstract. Based on the typical forms of traditional dwellings in Huize area and relevant literature, this study has protected and restored the existing details in accordance with the spatial patterns of traditional dwellings in courtyard 37, sandaoxiang, the ancient city, and partially demolished the later part of the traditional dwellings, and restored the spatial forms and details of the original traditional dwellings. At last, the function of the courtyard is replaced, so as to expand the use area of the courtyard building, improve the modern life infrastructure, meet the needs of residents' life and improve the quality of residents' life. In order to provide a certain reference value for the traditional residential building design in the similar historical blocks in China.

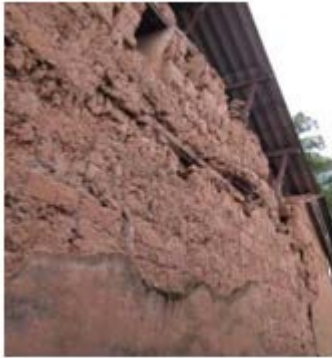
The walls of traditional houses in Huize ancient city are generally rammed walls or blue brick walls. In order to protect the walls and add beauty, the outer layer of some walls is covered with white lime layer. Because of its long history and disrepair, most of the white lime layer of the wall has been peeled off to a certain extent, and the rammed earth wall and brick wall exposed directly have also been corroded to a certain extent. In addition, due to the frequent occurrence of local earthquakes or other factors, some walls have cracks in varying degrees. There is also the

Fig 1. rammed earth wall with weathered cracks Fig 2. brick wall after demolition

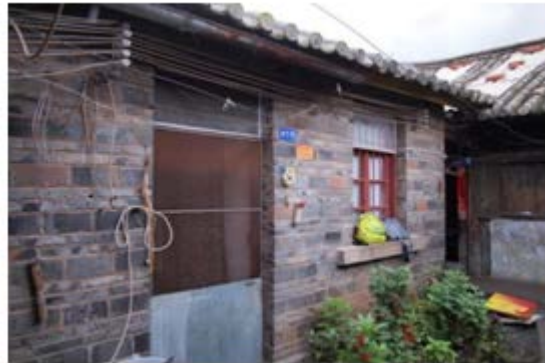
phenomenon that the original wall is demolished and replaced by brick wall in some extended houses.

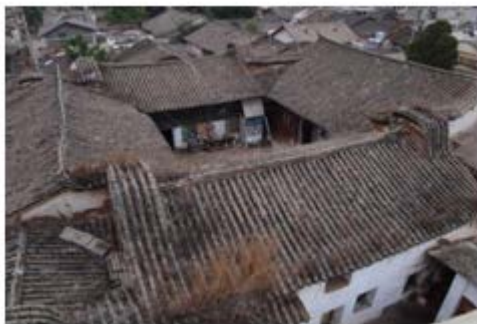
Fig 3. well preserved courtyard roof Fig 4. the roof is covered with a layer of cement

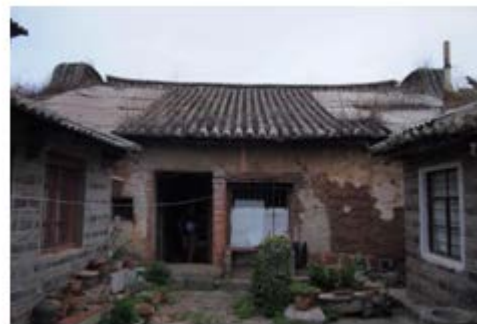
The roof of traditional houses in Huize ancient city is generally in the form of double broken tile roof, and the wing roof of some houses is in the form of asymmetric double slope roof. There are generally cat arch walls and cat holes on the local roof. Most of the existing cat holes are blocked by the residents and have no actual use function. Because the houses are old and in disrepair, the roofs of the houses are damaged to varying degrees. Some houses are replaced with new tiles by the residents, and some houses are directly added with a layer of cement asbestos tiles by the residents.

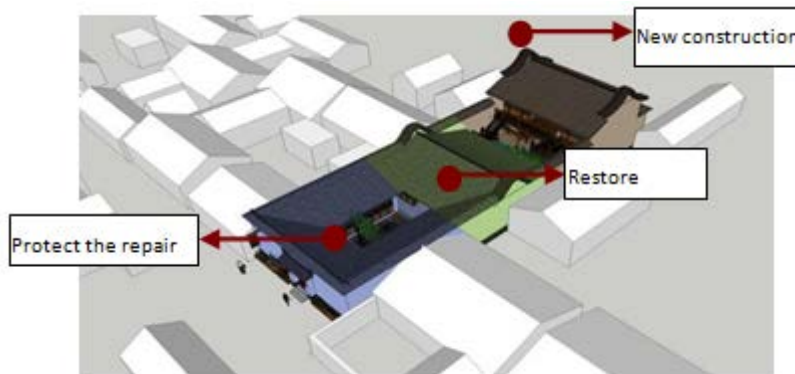
Fig 6. transformation strategy of No. 37 Institute
