Cause Analysis of Boeing 737MAX Accident

Jingxi Xia

Shenzhen Experimental School Middle School Department, China

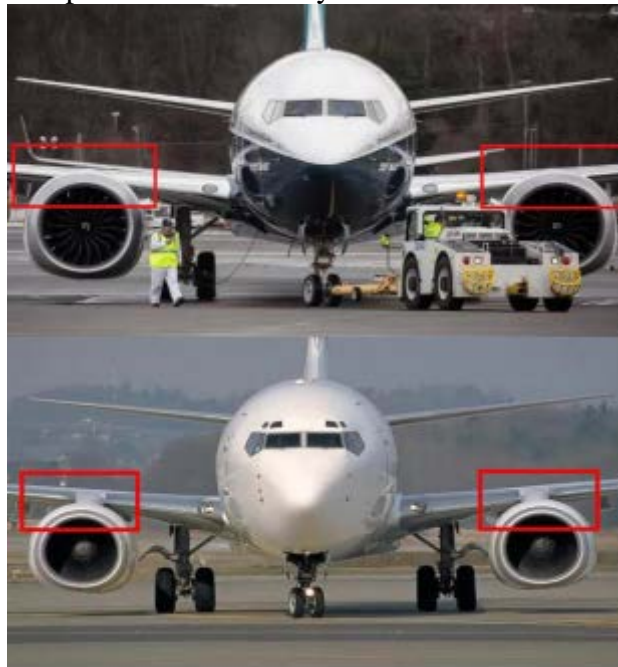
Figure 4. The figure above is 737MAX and the figure below is 737NG. The difference in engine position and is clear.

It has been mentioned above that the second-generation 737 has had problem with low height of the engine to the ground caused by short landing gear. The same problem occurred again when the 737MAX was replaced with the LEAP-1B engine, but the flat bottom of the engine does not solve the problem. Thus, Boeing moved the underwing lifting position of the engine forward and upward, making the whole engine hanging in front of the wing rather than the position right under the wing and lengthening the front landing gear. That did get the engine a little higher off the ground. However, the larger thrust of LEAP-1B and the change of engine position resulted in the increase of lift moment under high thrust, which increases the risk of aircraft stall.

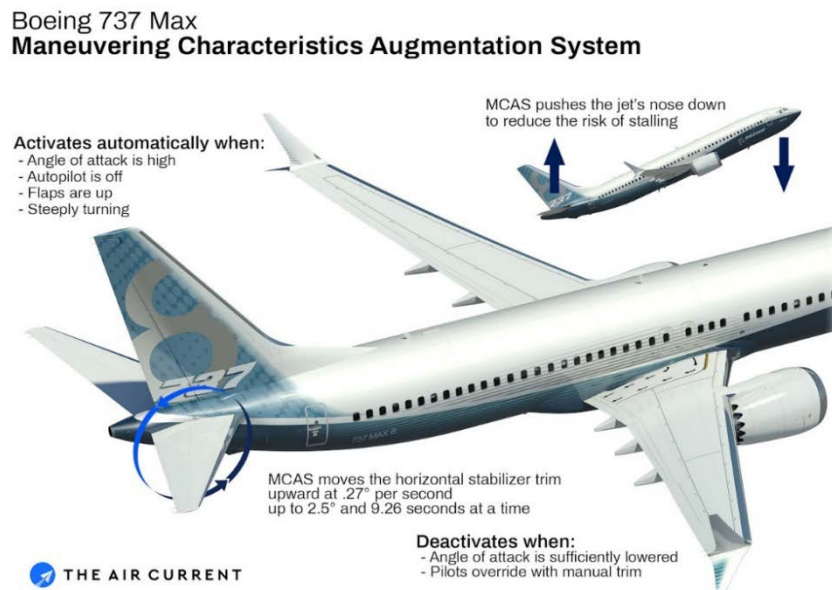
Figure 5. Schematic diagram of MCAS

Therefore, the original 737NG speed trim system with an added operation mode, Maneuver Characteristics Augmentation System (MCAS), was used as the speed trim system of 737MAX. MCAS will be triggered automatically when necessary, free from the intervention of pilots. The auto trigger of MCAS needs to satisfy all four conditions: autopilot is off, flaps are up, the pilots is not in manual trim, and angle of attack is high. The MCAS function will be triggered when data from the airspeed sensor and the main angle of attack sensor of the aircraft exceed the limit and the

aircraft will quickly trim (lift) the front ends of horizontal stabilizer of the aircraft to increase the nose-down tendency, thereby enhancing the pitching performance of the aircraft. It is obvious that it is not reliable to depend only on the output data from one side angle of attack sensor to judge the attitude of flight. Taking flight JT610 as an example, it encountered the situation that the MCAS function was triggered when only the main angle of attack data output from the main angle of attack sensor was malfunctioned so that the MCAS trimmed aircraft nose down in normal attitude. However, there are three angle of attack sensors on the aircraft. For the disagree of the angle of attack data, there are two angle of attack indicators and two angle of attack disagree alerts in 737MAX cockpit. However, these two items are optional, which means that the airlines can choose not to install the angle of attack indicator and the angle of attack disagree alert. These two crucial instructions were not installed on flight JT610.

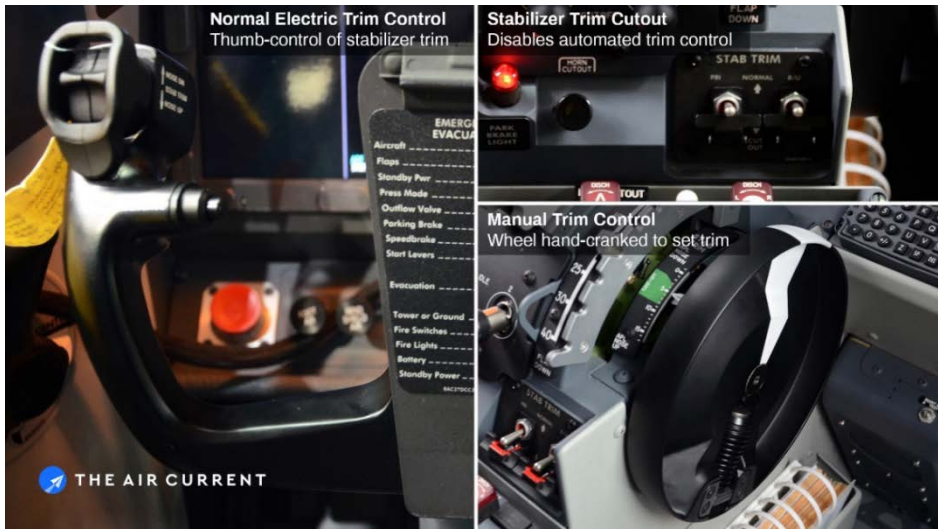
Figure 6. Three steps to disengage MCAS manually

In addition, after the 737MAX aircraft was delivered, the supporting Flight Crew Training Manual did not introduce MCAS, the new functions specular to 737MAX, until the flight JT610 crash. All the 737MAX pilots knew nothing about MCAS function. In this way, the difference between 737MAX and 737NG was reduced and airlines could reduce the cost of training 737NG pilots into 737MAX pilots, which made 737MAX more competitive. Only after a preliminary report of the JT610 incident pointed to the MCAS function, did Boeing explain the MCAS and submit to all airlines with 737MAX the recommended procedures for handling MCAS failures. Most airlines also provide timely emergency training for all 737MAX pilots. Different from the crew of JT610, the ET302 crew have received training on MCAS failures and implemented Boeing's recommended procedures in the event of MCAS failures. ET302 crew timely disconnected the normal electric trim system of horizontal stabilizer in the event of MCAS failure and manually trimmed the horizontal stabilizer. However, after the failure of manual trim, the crew re-connected the electric trim system of horizontal stabilizer, hoping that the system can automatically adjust the attitude of the aircraft to

normal, but the wrong angle of attack data triggered MCAS again to make the aircraft enter the dive status that cannot be recovered, resulting in the crash. Although the recommended procedures of Boeing do prevent the crash caused by MCAS failures in most cases, it seems that they are not applicable to the case of ET302.

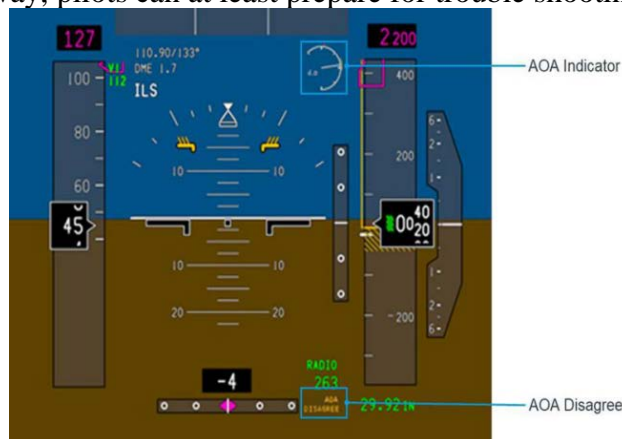
Figure 7. Angle of attack indicator and angle of attack disagree alert on the Primary Flight Display (PFD)

The last one that might have avoided these two accidents was Boeing’s optional angle of attack indicator and angle of attack disagree alert signal. Two independent angle of attack indicators are installed on the Primary Flight Display (PFD) on the left side of the captain and the right side of first-officer. The indicator on the captain side shows the data of the angle of attack sensor on the left nose side while the indicator on the first-officer side shows the data of the angle of attack sensor on the right nose side. On the one hand, the angle of attack indicator can intuitively let pilots know whether the angle of attack of the current aircraft is normal. On the other hand, when the difference between the left and right angle of attack indicator data is greater than 10 degrees in 10 seconds, the alert signals of angle of attack disagree will appear on the Primary Flight Display of two sides. They inform pilots the abnormal data of the angle of attack, which may lead to MCAS functions by mistake, in time. In this way, pilots can at least prepare for trouble shooting.
