Cause Analysis of Boeing 737MAX Accident

Jingxi Xia

Shenzhen Experimental School Middle School Department, China

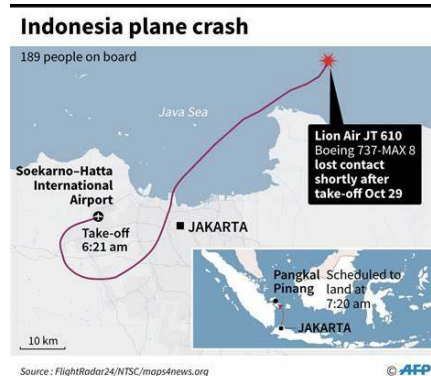
1. Process Summary of the Two Accidents

Figure 1. Flight path of JT610 flight

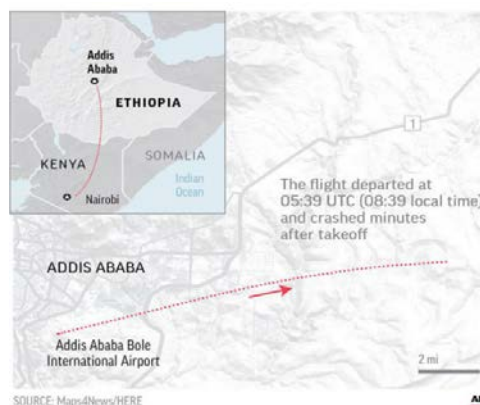
On March 10, 2019 local time, Flight ET302 of Ethiopian Airlines departed at Addis Ababa flying to Nairobi and lost contact six minutes later. It was later confirmed to have crashed and none of the 157 people on board survived. The Boeing 737MAX8 aircraft, which is less than five months old with registration number ET-AVJ, made its maiden flight on October 30, 2018 and was delivered to Ethiopian Airlines on November 15, 2018. The weather at the airport was fine when the accident occurred.

Figure 2. Flight path of ET302

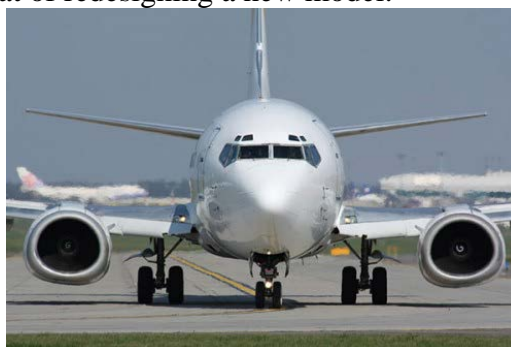
Figure 3. Front view of Boeing 737NG, flat engine bottom

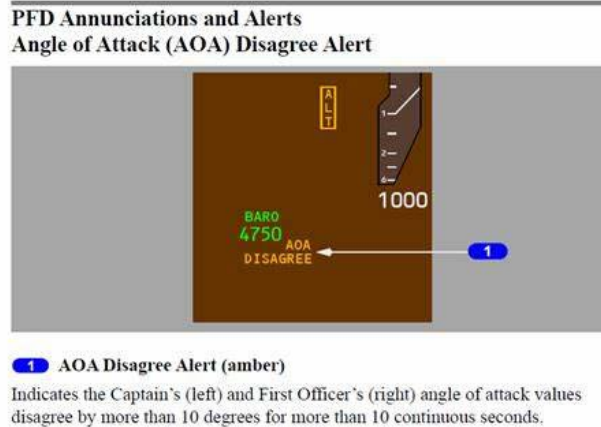
The last one that might have avoided these two accidents was Boeing’s optional angle of attack indicator and angle of attack disagree alert signal. Two independent angle of attack indicators are installed on the Primary Flight Display (PFD) on the left side of the captain and the right side of first-officer. The indicator on the captain side shows the data of the angle of attack sensor on the left nose side while the indicator on the first-officer side shows the data of the angle of attack sensor on the right nose side. On the one hand, the angle of attack indicator can intuitively let pilots know whether the angle of attack of the current aircraft is normal. On the other hand, when the difference between the left and right angle of attack indicator data is greater than 10 degrees in 10 seconds, the alert signals of angle of attack disagree will appear on the Primary Flight Display of two sides. They inform pilots the abnormal data of the angle of attack, which may lead to MCAS functions by mistake, in time. In this way, pilots can at least prepare for trouble shooting.

Figure 8. The Angle of attack alert instruction
