# Fatigue behavior of carbon fiber reinforced composite with different stacking sequence

**Keywords:** Carbon fibre reinforced composites; Mechanical properties; Fatigue behaviour; damage evolution.

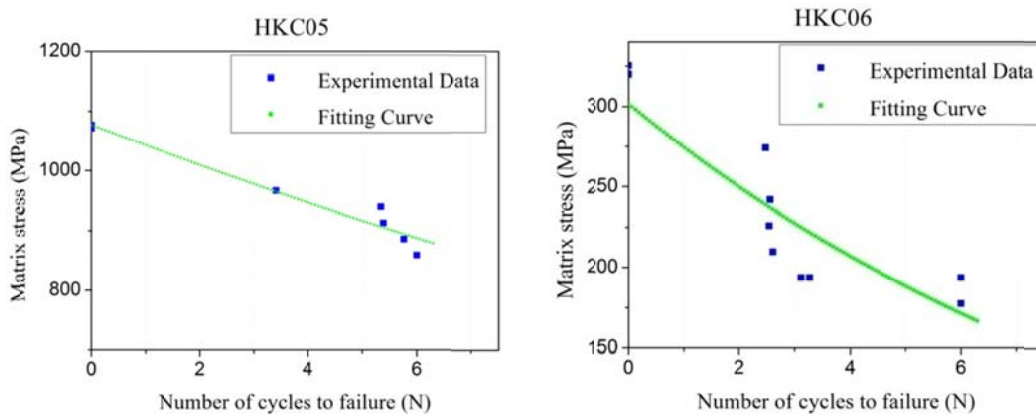
Maximum stress vs fatigue life curves of HKC05 and HKC06 specimens were shown in fig 2, and the experiment data was fit with Basquin fatigue equation, using least square method. The

abscissa axis in fig. 2 denotes number of cycle N in logarithmic scale and ordinate axis denotes maximum stress amplitude. The fitted equations were following:

Figure 2: Maximum stress vs fatigue life of HKC05 and HKC06 specimens

$$\delta = 1087.2 \times (2N)^{-0.014} \quad (1)$$

$$\delta = 310.3 \times (2N)^{-0.0409} \quad (2)$$

While, the Basquin coefficient of HKC05 was 1087 MPa, That about three times over HKC06, and Basquin exponent was -0.014, which was -0.041 for HKC06. Experiment data of above samples indicated that, the direction of carbon fibre in 0o layers of HKC05 was major bearing direction, which was main bearing layer. But the distribution and redistribution of 0o layers and 90o layers were more ambiguous and vague.
